Seismic strengthening of severely damaged beam-column RC joints using CFRP

Abstract

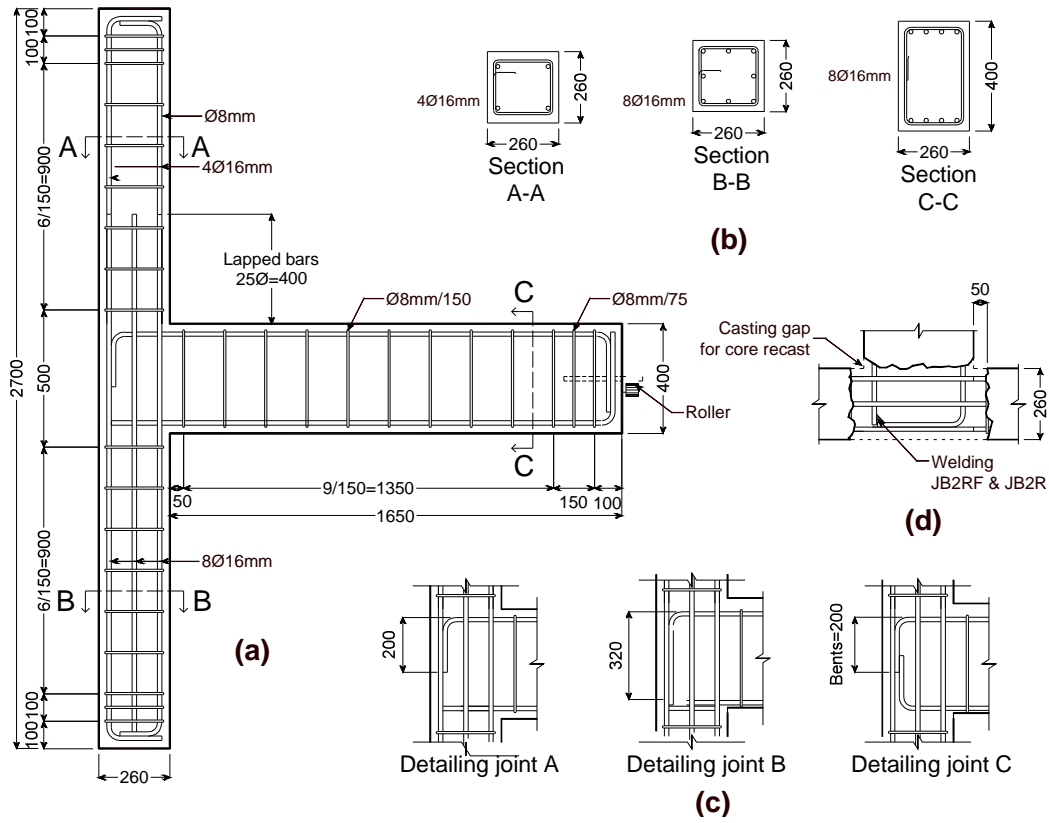
Fig. 1. General geometry and reinforcement details of tested joints (units: mm)

The specimens simulated a full-scale 2D exterior joint between contra-flexure points of a floor in a multi-story moment-resisting frame, but excluding the slabs (see Fig. 1(a)). The column had a cross section of 260×260 mm and a height of 2700 mm. The longitudinal column reinforcement consisted of 16 mm bars (see Fig. 1(b)). These bars were lapped over a length $l_b=25d_b$ (d_b = bar diameter) just above the joint core to represent typical construction practices of developing countries.

The beam had a cross section of 260×400 mm and a length of 1650 mm. The main flexural reinforcement consisted of 16 mm bars as shown in Fig. 1(b). Three types of anchorage detailing were examined for the top beam reinforcement as shown in Fig. 1(c). To study the effect of deficient bar anchorage, the bottom beam reinforcement of detailing types A and B was anchored into the joint for a length of 220 mm only (approximately $14d_b$), with no hooks or bends. This short anchorage length would be deemed insufficient to develop the full capacity of the 16 mm bars according to current design recommendations. The column-to-beam relative flexural strength ratio ($\Sigma M_{Rcol}/\Sigma M_{Rbeam}$) of the specimens was approximately 1.0, and therefore the strong column-weak beam strength hierarchy intended by current design philosophy was not satisfied. Moreover, the specimens were designed to fail at the core where no confining stirrups were provided. To prevent a shear failure outside the joint core, the column and beam were reinforced with 8 mm transverse stirrups spaced at 150 mm centers. The stirrups were closed with 90° hooks instead of 135° hooks typically required by current seismic codes.

The joints were cast using two batches of ready mixed concrete. A steel roller was inserted at the center of the cross section of the beam tip during casting, as shown in Fig. 1(a). Following casting, the specimens were cured for seven days in the formwork and then stored under standard laboratory conditions. The mean concrete compressive strength (f_{cm}) was determined from tests on three 150×300 mm concrete cylinders according to BS EN 12390-3 (BSI 2009a). The indirect tensile splitting strength (f_{ctm}) was obtained from tests on three 100×200 mm cylinders according to BS EN 12390-6 (BSI 2009b). All cylinders were cast at the same time and cured together with the joints. Table 1 summarizes the mean values and standard deviations obtained from the tests.

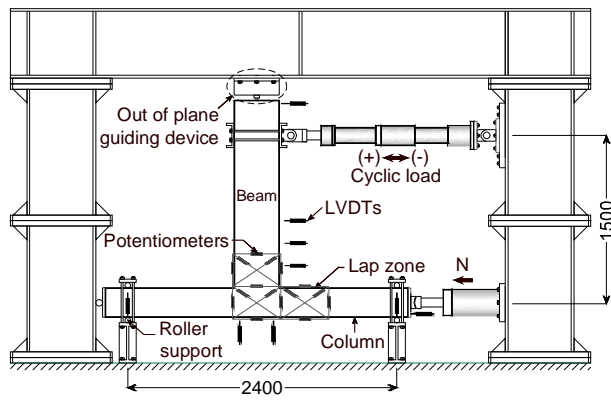
Fig. 2. Test setup and instrumentation of joints (units: mm)

The joints were tested with the column in horizontal position as shown in Fig. 2. A guiding device consisting of an oiled roller inserted between two parallel steel plates was used at the beam tip to restrain possible out-of-plane movement at large displacements, but such device allowed free displacement and rotation of the beam in the direction of testing. Displacements were monitored using Linear Variable Differential Transformers (LVDTs) at the locations shown in Fig. 2. Deformations of the joint core were also measured using a set of 16 linear potentiometers. The strain developed along the beam and column steel reinforcement and CFRP sheets was monitored using strategically placed foil-type electrical resistance strain gages (see Fig. 3(a)).

The cyclic load was applied to the beam in displacement control using a servo-hydraulic actuator (see Fig. 2). Three push-pull cycles were applied at drift ratios δ (δ =beam tip displacement/beam length) of $\pm 0.25\%$, $\pm 0.5\%$, $\pm 0.75\%$, $\pm 1.0\%$, $\pm 1.5\%$, $\pm 2.0\%$, $\pm 3.0\%$, $\pm 4.0\%$ and $\pm 5.0\%$. Cycles at $\delta \pm 0.75\%$ and $\pm 1.5\%$ were not applied in phase 2 to reduce the testing time. Each cycle was applied in the push (+) direction first, which tensioned the top beam reinforcement. A second actuator applied a constant axial load $N=150$ kN on the column (see Fig. 2), which corresponds to an approximate axial load ratio $v=N/(f_{cm}A_g)=0.07$, where A_g is the column gross cross sectional area. The formation and development of cracks were monitored continuously during the test. Moreover, the tests were paused at the onset of the first visible diagonal core cracking (which appeared suddenly) to record the applied load and tip displacement. The tests were halted when the load capacity of the joints dropped to approximately 50% of the peak load.

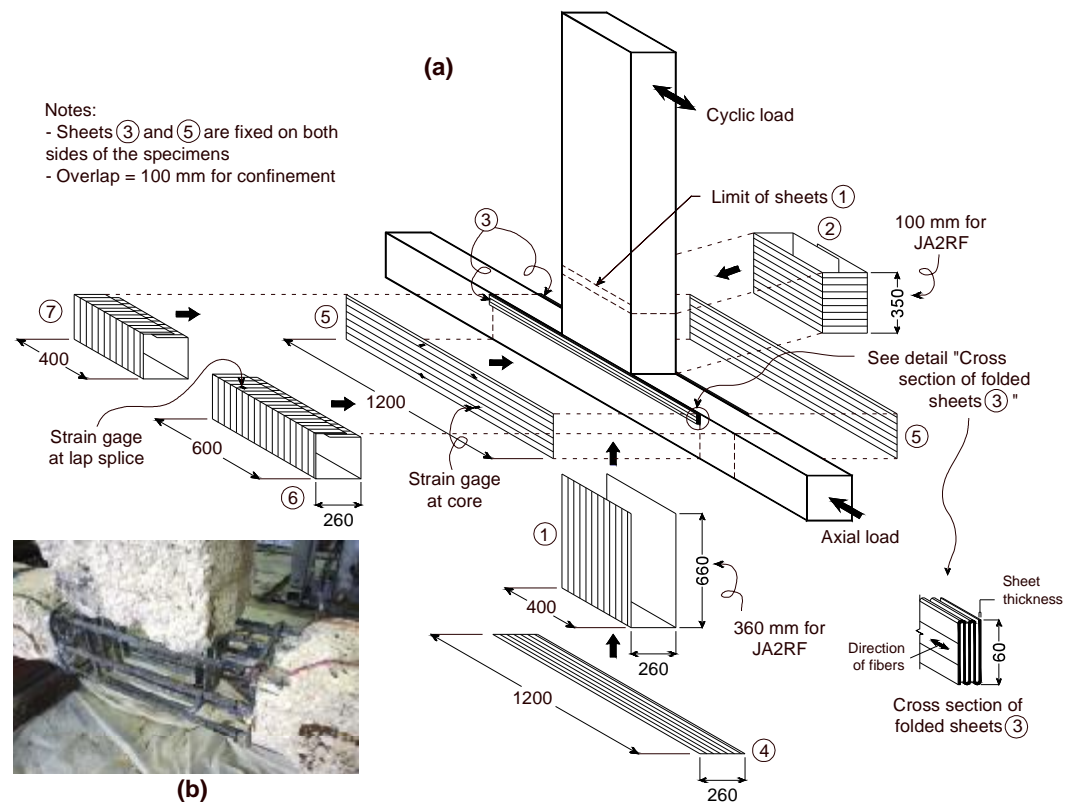
Fig. 3. (a) CFRP strengthening strategy, and (b) removal of CFRP and core replacement in joint JB2RF (units: mm)

Fig. 3(a) shows a general view of the CFRP strengthening sequence. The main goal of the strengthening was to develop the plastic capacity of the beam reinforcement. To achieve this, the premature failure of the core zone had to be prevented and the flexural capacity of the column enhanced.

Accordingly, a minimum of two layers of CFRP were required to strengthen the joint core. As shown in Fig. 3(a), U-shaped CFRP sheets strengthened the joint core to increase its shear strength (layer ①). Confining sheets (layer ②) were then wrapped around the beam to prevent premature debonding of the U-shaped sheets.

The flexural capacity of the column was increased by bonding CFRP sheets parallel to the column axis (layers ③ and ④ in Fig. 3(a)). The number of layers required to satisfy a hierarchy strength $\Sigma M_{Rcol} > 1.3 \Sigma M_{Rbeam}$ was determined using conventional moment-curvature analysis assuming perfect bond between CFRP sheets and concrete. The presence of the beam hindered the continuity of sheets ③ on the inner part of the column. To avoid interrupting or mechanically anchoring sheets ③ in the beam section, these sheets were folded and bonded on the column faces. As a result, sheets ③ provided slightly lower flexural strength in comparison to sheets ④. Nonetheless, detailed moment-curvature analyses indicate that such difference is less than 10%, which is acceptable for practical strengthening applications. An additional layer of CFRP (⑤) was bonded on both sides of the column to keep sheets ③ in place during the subsequent installation of the confining sheets. Finally, sheets ⑥ and ⑦ were used to increase the ductility of the column and to avoid premature debonding of ③, ④ and ⑤.

After the tests on joint JB2RF, the CFRP sheets were completely removed and the core was replaced again following the same procedure described previously (see Fig. 3(b)). Post-tensioned steel strapping was applied to the beam and column outside the core to promote the development of shear cracks in the core, and the joint was retested (JB2R).

core sets, thus allowing the preparation of concrete surfaces for the application of CFRP sheets. In real CFRP strengthening applications adopting the layout shown in Fig. 3(a), sheets ③ could be bonded (completely unfolded) on the inner face of the column, and then secured using mechanical CFRP anchors embedded in the concrete. Such anchoring solution was proven effective at preventing debonding of the CFRP strengthening on a substandard full-scale RC building tested by the authors (Garcia et al. 2010).

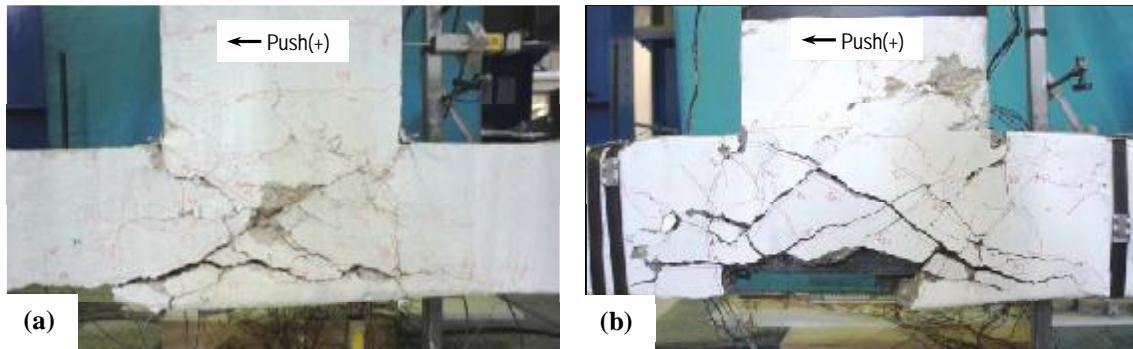
Fig. 4. Typical failure of (a) bare joints (JB2), and (b) rehabilitated joint JB2R

The progression of damage and final failure mode of the bare and rehabilitated joints were very similar. Despite the short anchorage length of the bottom beam reinforcement, pull out failure was not observed. This was confirmed by experimental observations (no cracks formed at the beam-joint interface) and by comparison of readings from strain gages fixed on the bars with displacements. Narrow splitting cracks formed along the spliced reinforcement in the column. As shown in Fig. 4(a) and (b), final failure of the bare and rehabilitated specimens was dominated by extensive diagonal cracking and partial concrete spalling in the core zone (J-type failure).

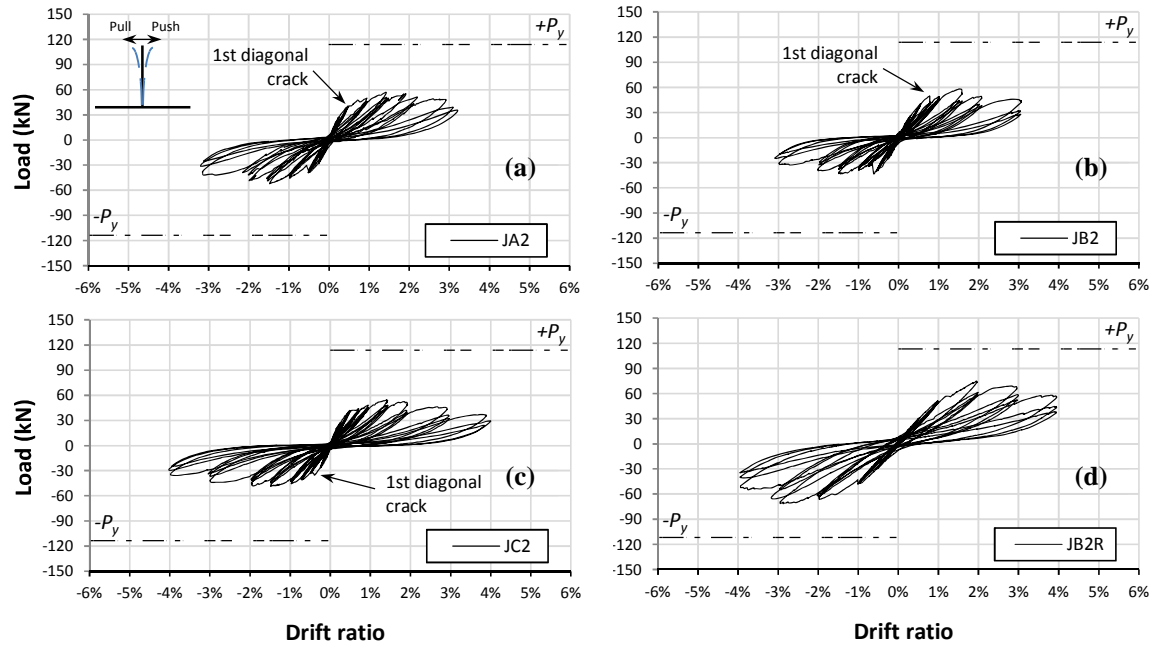
Fig. 5. Load-drift response for (a)-(c) bare joints, and (d) rehabilitated joint JB2R

The load-drift responses of the bare joints (Fig. 5(a)-(c)) show that the specimens remained elastic until the onset of diagonal core cracking, when the load dropped slightly. Despite the lack of steel stirrups, the bare specimens failed gradually and sustained drifts of up to $\pm 4.0\%$ (JC2 in Table 3). Such gradual failure is attributed to progressive crushing of the diagonal concrete strut in the joint core. As shown in Table 3, the load and drift at the onset of diagonal cracking were similar for all bare joints, regardless of the type of detailing in the beam reinforcement. The peak load for all bare joints was achieved at very similar $\delta_{max} \pm 1.4$ -

The load-drift relationship of joint JB2R in Fig. 5(d) shows the effect of core replacement on the shear strength of the joint (see also Table 3). Compared to JB2, the rehabilitation enhanced the peak capacity of joint JB2R by an average of 44%. This confirms that, in spite of severe damage produced in the joints during testing phases 1 and 2, the high-strength concrete used in the core recast and the welding of the top and bottom beam reinforcement (JB2R only) enhanced considerably the joint capacity. Note that although the beam reinforcement did not pullout during the tests, such bars were welded in JB2R to correct excessive permanent deformations and to assess the effectiveness of this strengthening solution as pullout failure was not desired. This approach was also adopted in the joints of a full-scale building tested recently by the authors (Garcia et al. 2014a).

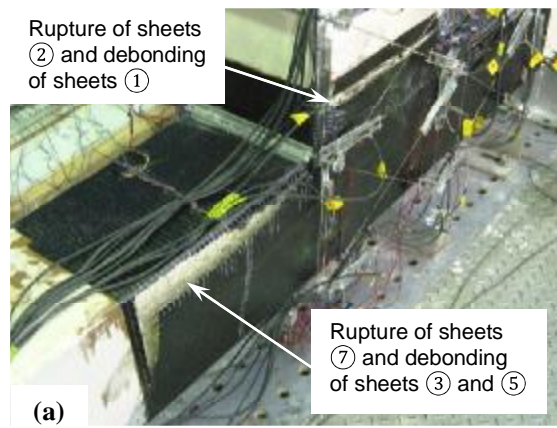
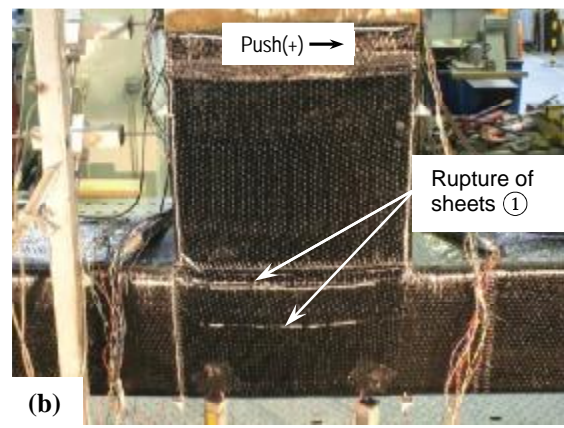
Fig. 6. Failure mode of specimens (a) JA2RF, and (b) JB2RF

③) at $\delta \pm 5.0\%$ and $\pm 4.0\%$ in joints JB2RF and JC2RF, respectively. Although no mechanical anchors were used, sheet debonding did not occur in these joints. Fig. 6(a) and (b) show specimens JA2RF and JB2RF at the end of the tests. The removal of the CFRP sheets after the tests revealed extensive diagonal cracking in the core, but the width and extension of cracks reduced considerably in comparison to the bare specimens. No evident damage was observed in the lap splices or in the columns outside the CFRP-strengthened area. However, the beams of joints JB2RF and JC2RF experienced significant flexural cracking outside the CFRP-strengthened region.

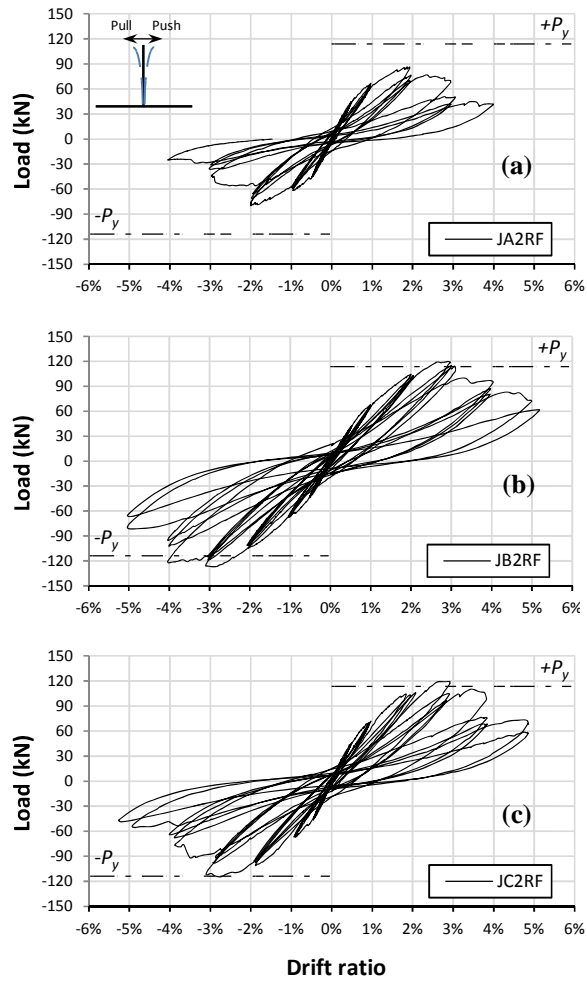
Fig. 7. Load-drift response for rehabilitated and CFRP-strengthened joints

Fig. 7(a) to (c) show the load-drift relationships for the CFRP-strengthened specimens. The combination of core replacement and CFRP strengthening enhanced significantly the load and deformation capacity of the joints. Compared to the bare counterparts, the peak load of specimens JA2RF, JB2RF and JC2RF increased by an average of 52%, 145% and 128%, respectively (see Table 3). Moreover, the peak and ultimate drift ratios of the joints also increased by up to 97% and 67%, respectively (joint JB2RF). Fig. 7(a) to (c) show that the area enclosed by the hysteretic loops is significantly larger for the CFRP-strengthened joints than for the bare specimens, which implies that these joint had a higher energy dissipation capacity.

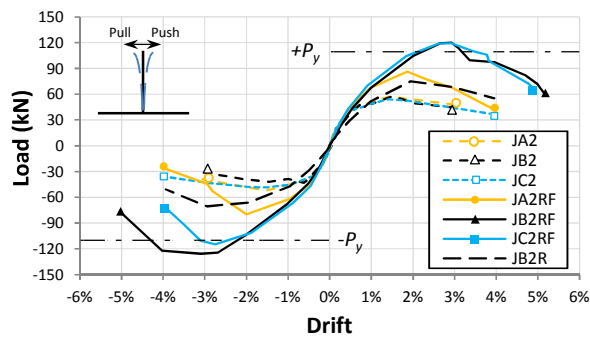
Fig. 8. Comparison of envelope from test results

Fig. 8 shows envelopes of the load-drift ratio relationships of the tested joints. The results indicate that the bare specimens resisted only 40-55% of the load required to develop the plastic capacity of the beam, P_y (see also Table 3). The peak load of specimen JA2RF reached 78% of P_y as premature debonding of the CFRP sheets occurred. In contrast, specimens JB2RF and JC2RF developed some yielding in the top and bottom beam reinforcement as shown by short post-yield incursions in Fig. 8. Readings from strain gages also confirmed that the beam reinforcement of the joints developed strains of up to 4000-5000 $\mu\epsilon$ (e.g. Fig. 9). As a result, joints JB2RF and JC2RF failed in a more ductile BJ-type mode (i.e. joint failure after yielding of beam reinforcement), thus achieving the strengthening goals. However, CFRP rupture and excessive damage in the joint core prevented the development of larger plastic strains in the beam reinforcement.

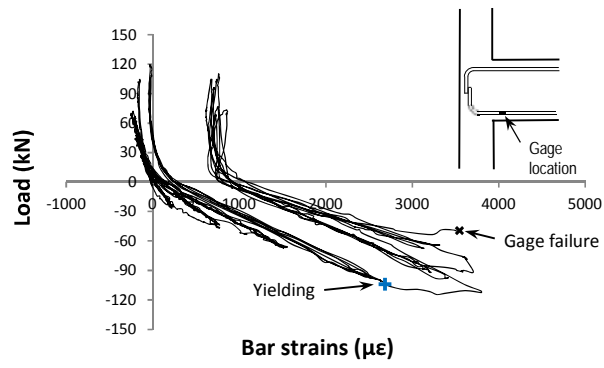
Fig. 9. Strains recorded at bottom beam reinforcement of joint JC2RF

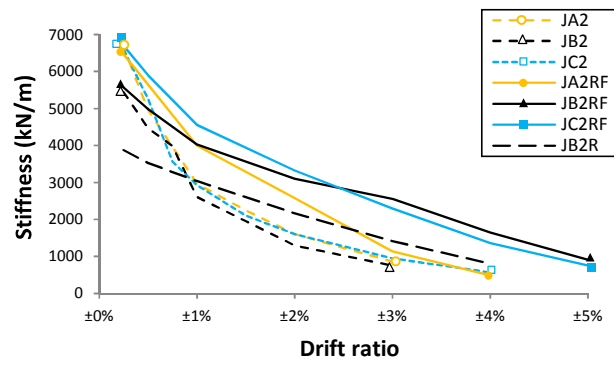
Fig. 10. Stiffness degradation of tested joints

Fig. 10 compares the stiffness degradation of the tested specimens. The secant stiffness is defined by the slope of a line connecting the maximum drifts in the push and pull directions of the first hysteresis loop. The results indicate that the core recast was very effective at restoring the original stiffness of the CFRP-strengthened specimens. The stiffness of JB2R was not fully recovered and this can be attributed to the flexural cracks formed in the beam of this joint during the previous tests (JB2 and JB2RF, see Fig. 10). In comparison to the bare specimens, it is also evident that the CFRP strengthening of the joints reduced significantly the rate of stiffness degradation. The fast stiffness deterioration after $\delta \pm 2.0\%$ in the CFRP-strengthened specimens can be attributed to the onset of CFRP rupture and to damage in the core.

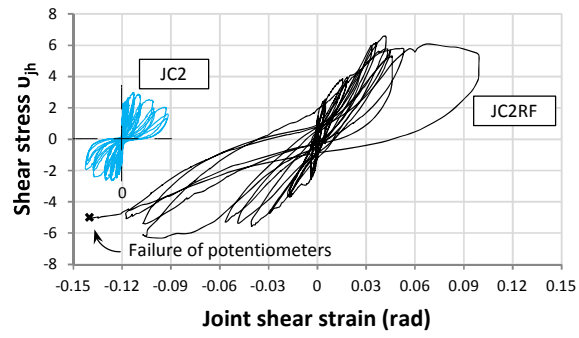
Fig. 11. Shear stress-strain of specimens (a) JC2, and (b) JC2RF

Fig. 11 compares the experimental shear stress-strain response of joints JC2 and JC2RF, which are representative of the rest of the specimens. Shear strains were derived using average measurements of the linear potentiometers located at the joint core. Results in Fig. 11 are only shown up to the point where the potentiometers failed, after reaching the joint capacity. It is shown that average joint strains at peak load (P_{max}) of specimens JC2 and JC2RF were 0.0067 and 0.069 rad, respectively, whereas maximum joint strains were 0.025 and 0.11 rad. The considerable enhancement in joint deformation capacity of joint JC2RF is attributed to the rehabilitation/strengthening intervention. Due to space limitations, the detailed analysis of the joint strains will be published by the authors in a future paper.

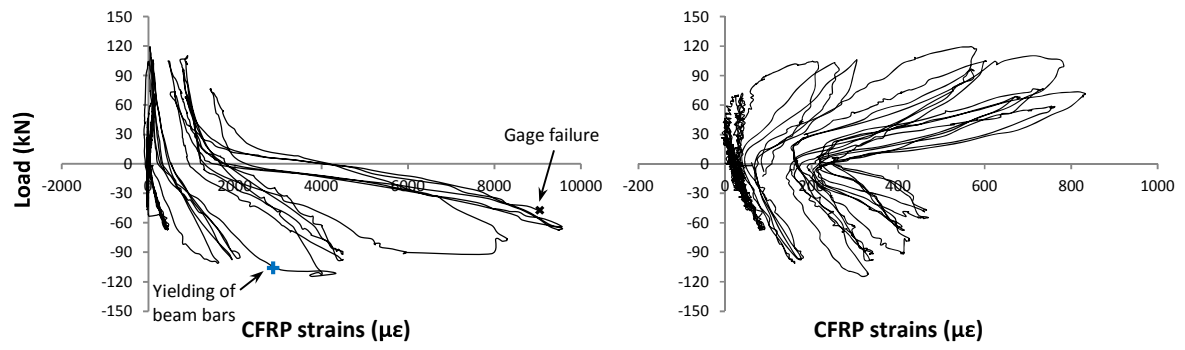
Fig. 12. Strains recorded in CFRP sheets at (a) core and (b) column lap splices of joint JC2RF

Typical strain readings (see Fig. 12(a)) from gages located at the core zone of the specimens indicate that, as expected, CFRP strains were negligible at the beginning of the test and increased after the onset of diagonal core cracking. In general, the CFRP strain values measured at peak load (P_{max}) varied from 2500 $\mu\epsilon$ (joint JA2RF) to 7300 $\mu\epsilon$ (JB2RF), and at ultimate drift (δ_u) varied from 11900 $\mu\epsilon$ (JA2RF) to 16900 $\mu\epsilon$ (JB2RF). The latter values correspond to 70% and 100% of the ultimate strain of the CFRP sheets, respectively. Fig. 12(b) shows typical strain readings from gages fixed on the confining sheets (6) at the mid-point of the lap splice length (see Fig. 3(a)). Overall, maximum strains at P_{max} varied from 200 to 570 $\mu\epsilon$ only, whereas strains at δ_u were always lower than 1000 $\mu\epsilon$. These results confirm previous research by the authors (Garcia
